# **Field Report for Airborne Data Collected In Support of US EPA Region 6 Intercontinental Terminals Company LLC Fire 10 April 2019**

## **Data Results Flight 23, 10 April 2019**

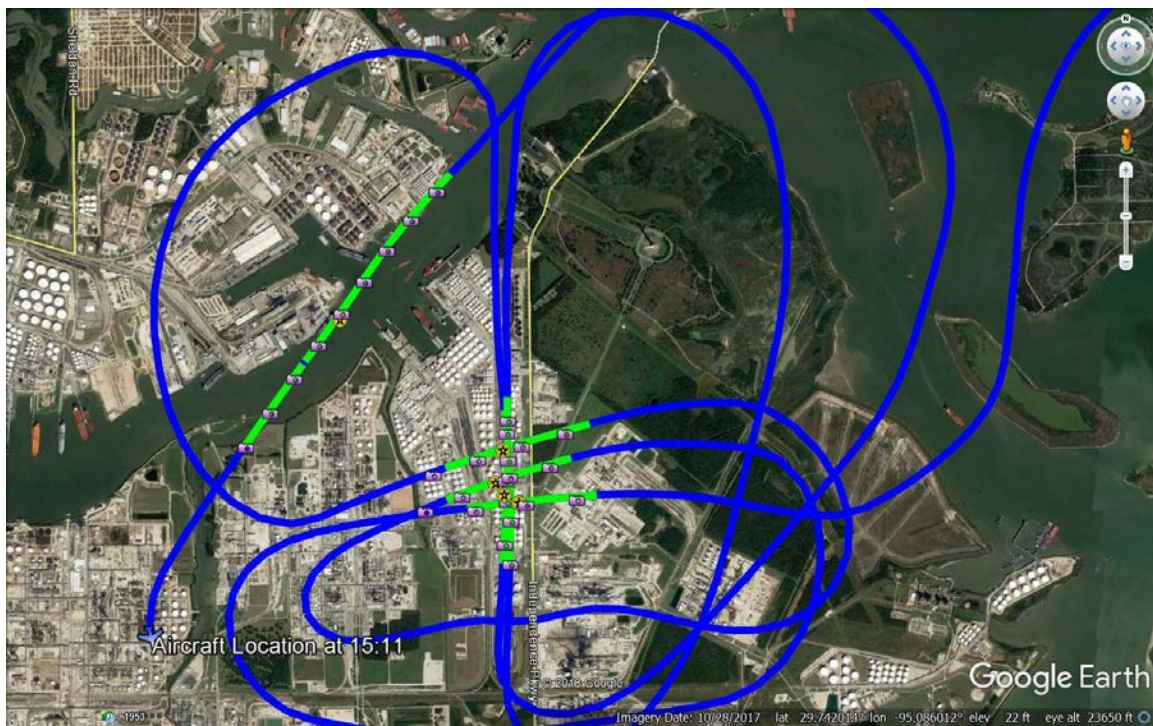
Figure 2: Flight line data for 10 April 2019, Flight 23. The blue lines represent the ASPECT flight path, green lines represent when the Infrared Line Scanner was actively collecting data, and the camera icons represent when a photo was taken.

The time for lift-off was given as 0930. The aircraft was over the site at 0954 and collected a total of 6 data collection passes over the ITC site. Flight information is summarized in Appendix A and Figure 2.

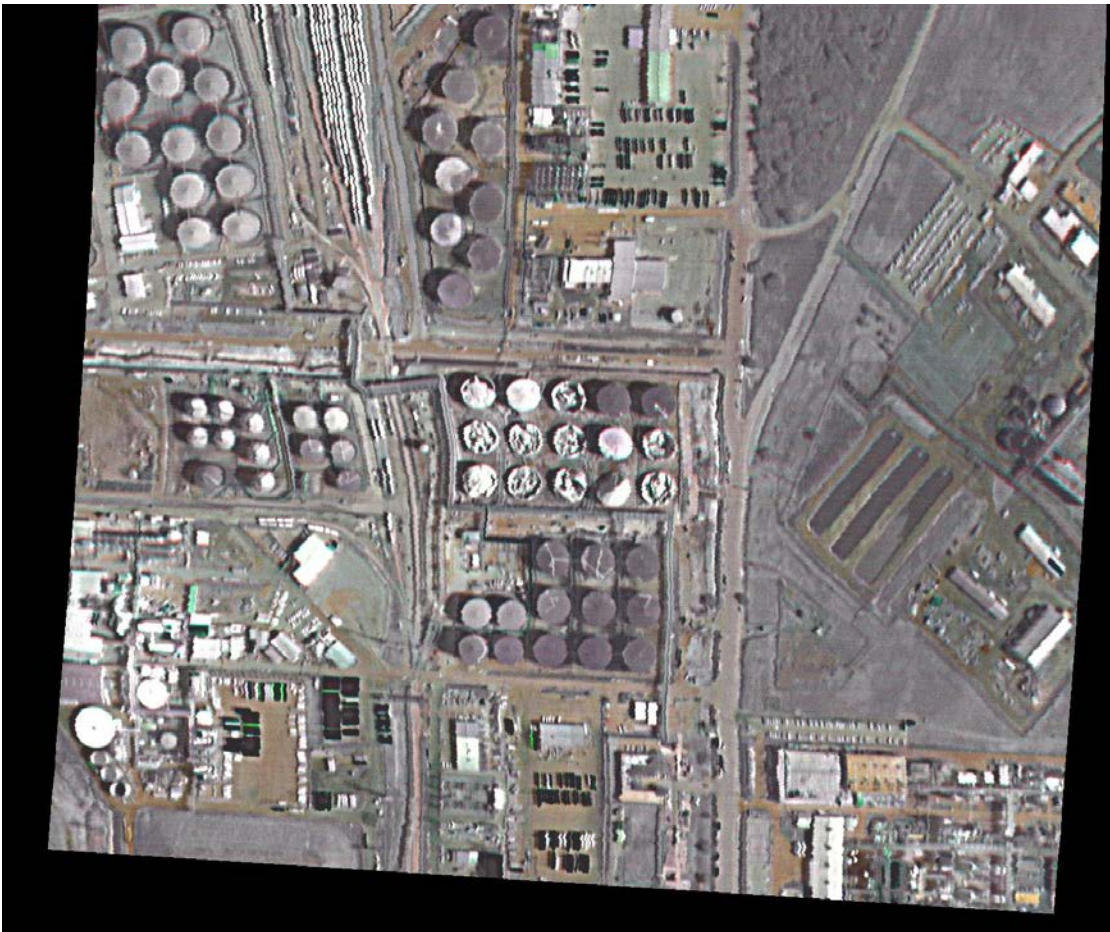
A total of 1 test and 5 data passes were made in the proximity of the impacted tank farm and also in extended areas surrounding the site and infrared line scanner images were generated for each pass. Figure 3 shows a typical 3-band infrared image obtained from data collected for Run 5. No significant difference was noted between this image and those collected on 9 April 2019.

Figure 3: IR image of ITC data for 10 April 2019, Flight 23, Run 5

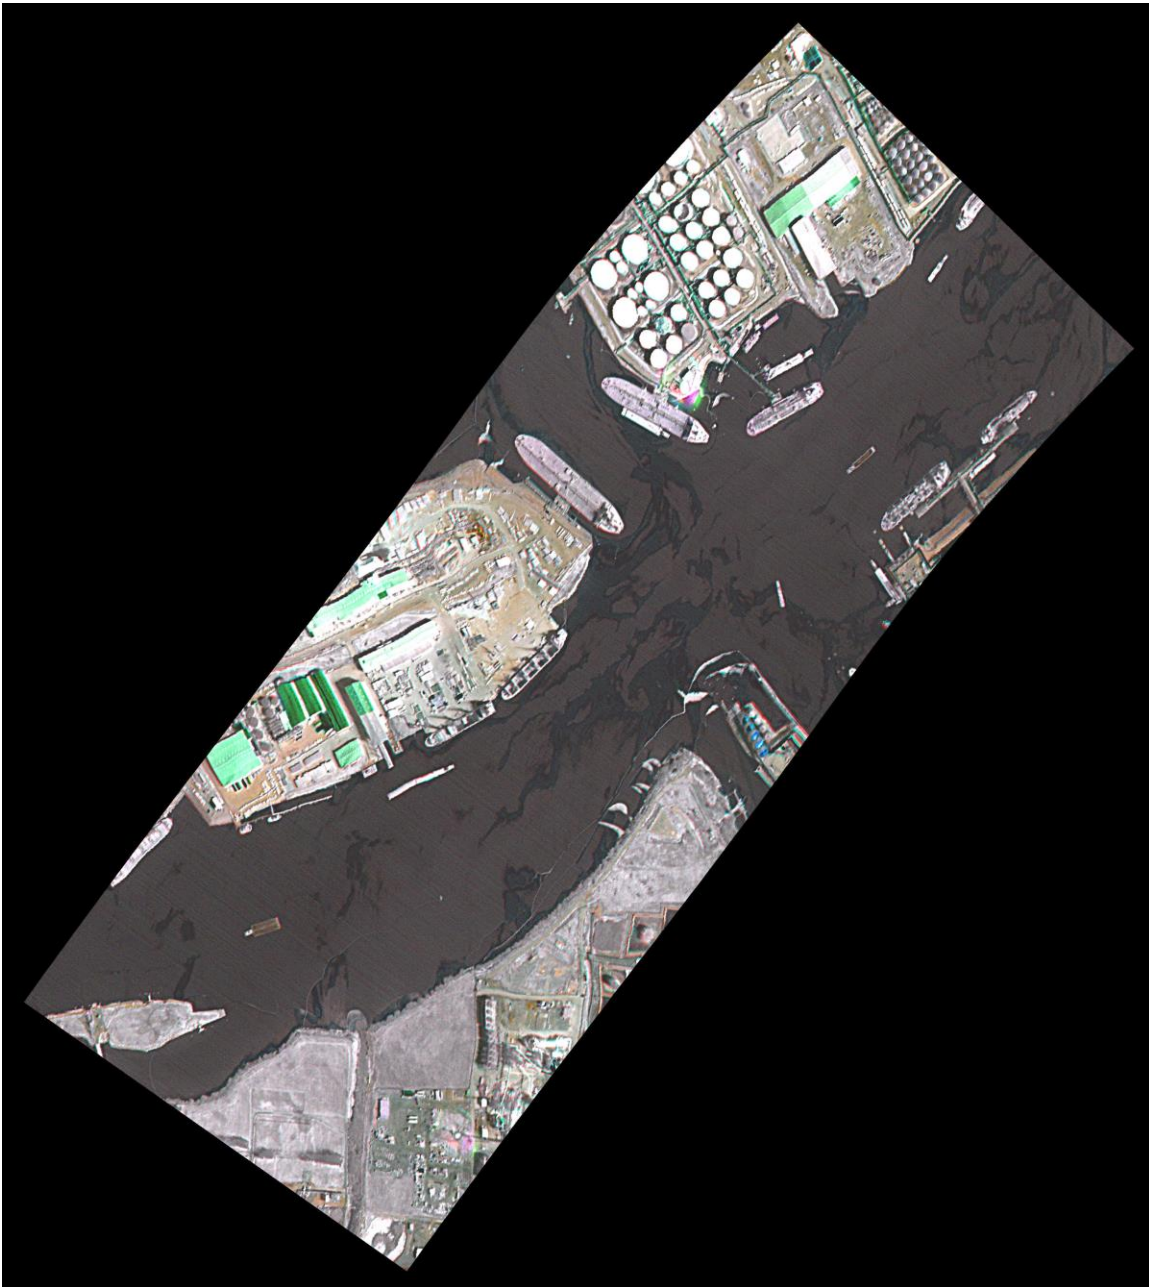
Figure 4 provides an IR image of the confluence area. Some product (shown as white) can be observed within the boom structure namely product pushed to north by the wind. Little change in the apparent quantity of product is evident from the prior flight on 9 April 2019. Very light sheen or possibly prop wash (cooler upwelling water) is present in the channel with no significant leakage from the booms.

Figure 4: IR Image of Contained Oil 10 April 2019, Fight 23, Run 6

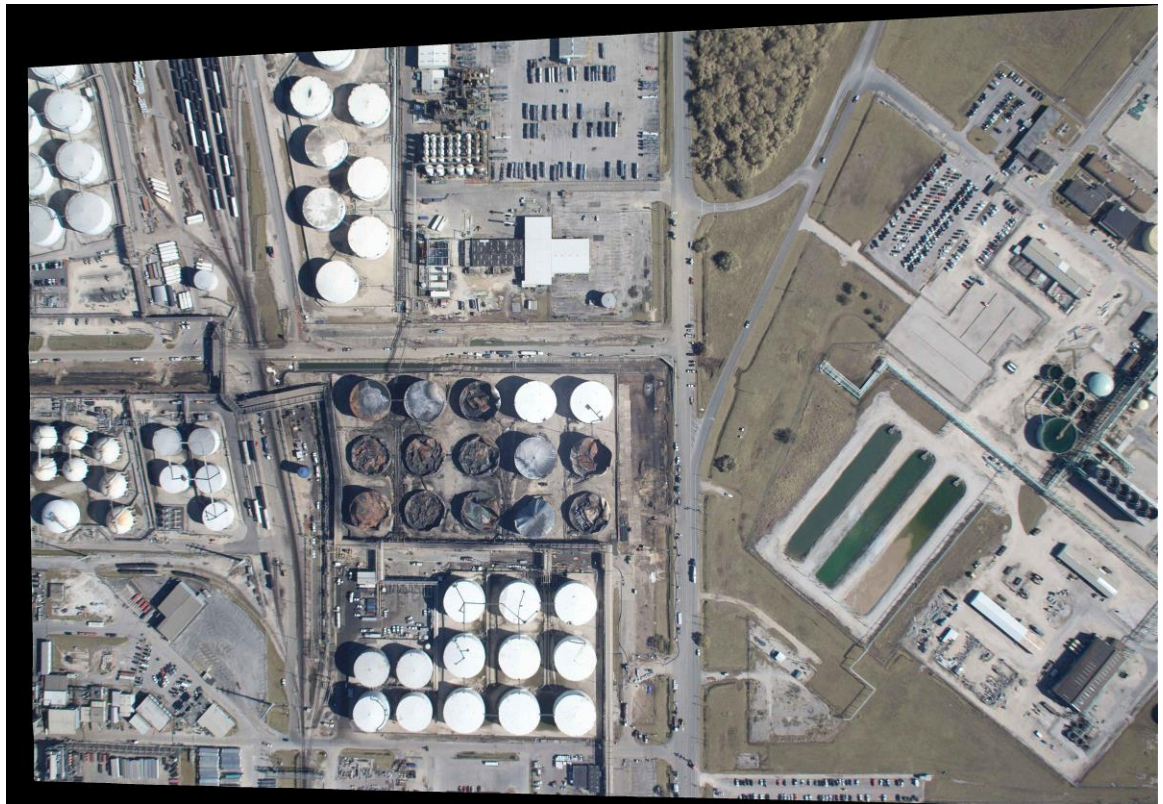
A full set of high resolution aerial digital photography was collected as part of the flight. Figure 5 and 6 show representative overhead images collected as part of each pass over the tank farm. Examination of the image shows no change in the status of the tank farm from the previous flight on 9 April 2019. A similar conclusion can be reached by referring to the oblique image.

Figure 5: Aerial Image of the Tank Farm, 10 April 2019, Flight 23

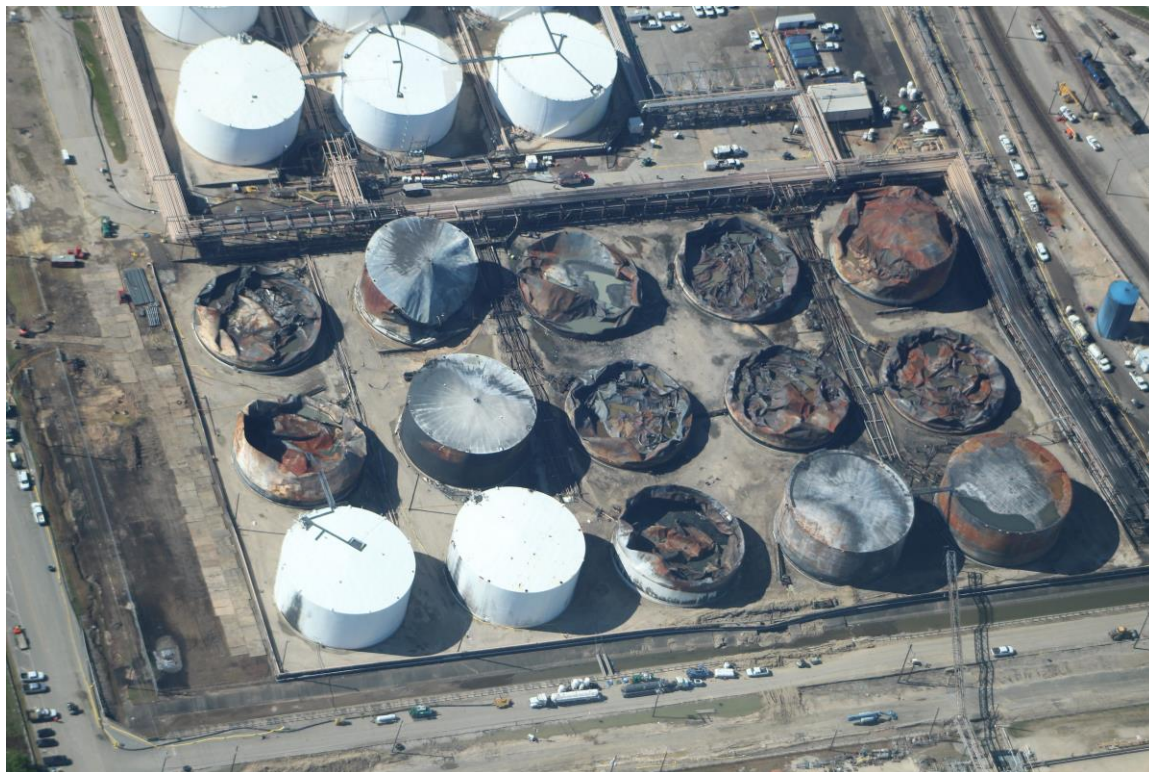
Figure 6: Oblique Image of the Tank Farm (looking south), 10 April 2019 Flight 23

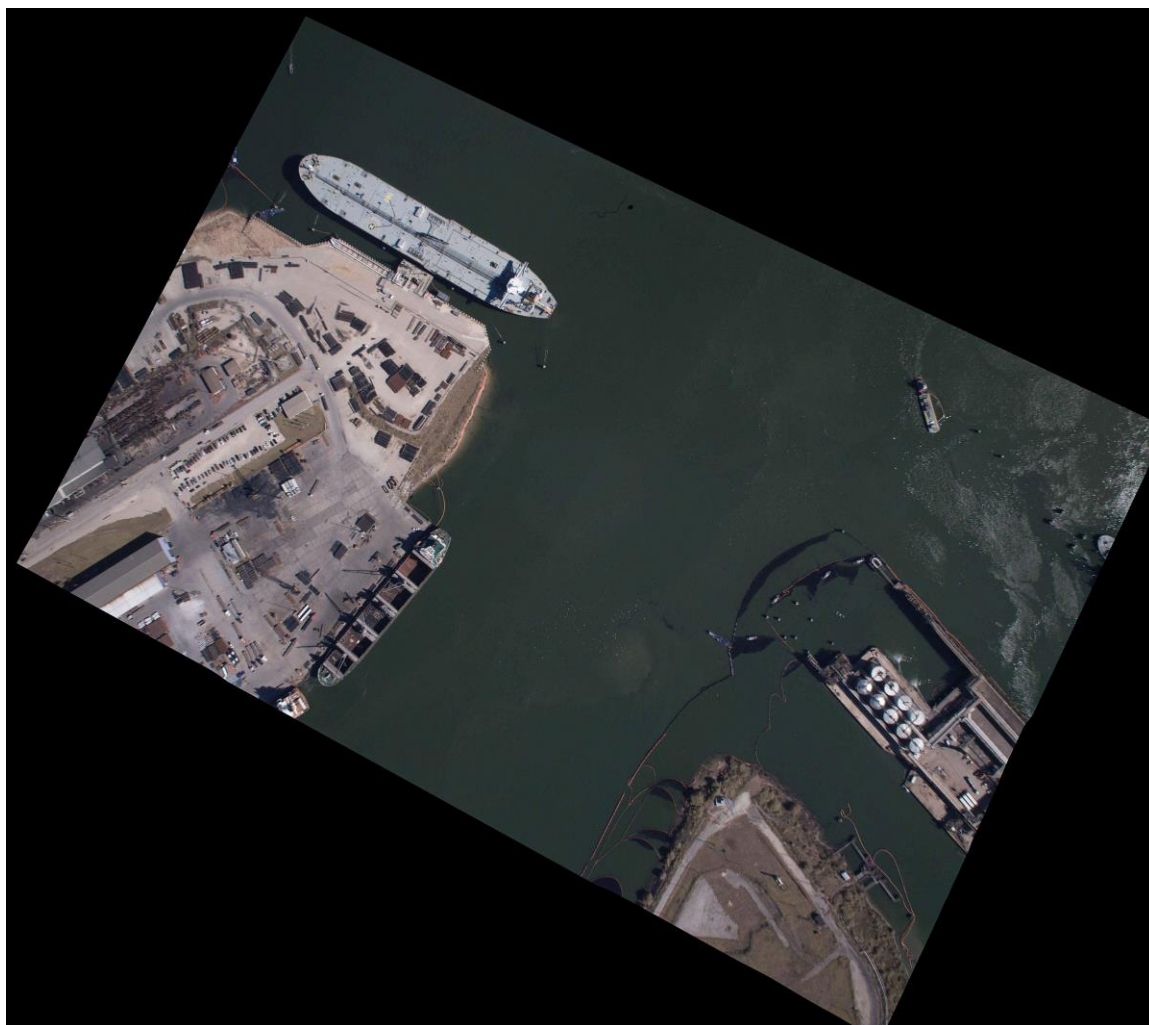
Figure 7 shows an aerial image collected over the confluence area. As observed in the IR image, trapped product has been pushed against the booms due to the southerly wind. Examination of the main channel shows what appears to be some product in the wake of the boom tug. The oblique image (Figure 8) also shows what appears to be a small amount of product in the main channel. No other leakage is evident. No sheen is present in the image.

Figure 7: Aerial Image of the Ship Channel Boom Area, 10 April 2019, Flight 23

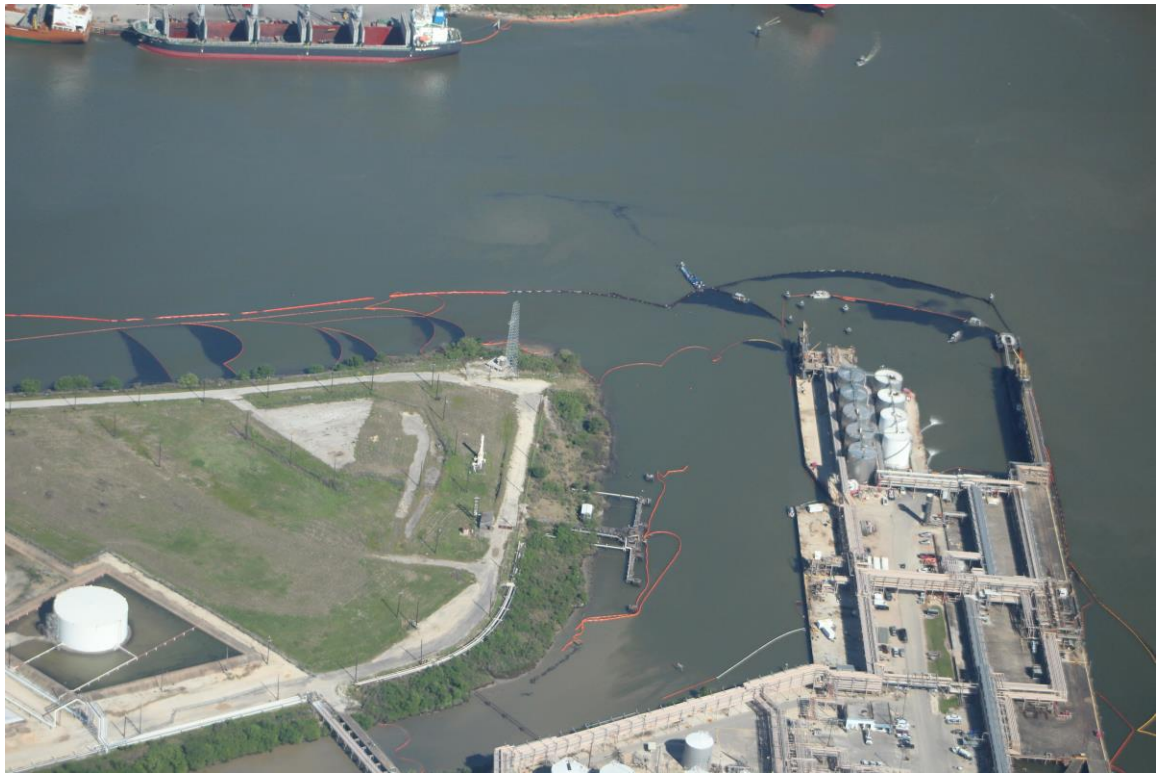
Figure 8: Oblique Image of the Ship Channel Boom Area, 10 April 2019, Flight 23
